Nuclear energy / uranium mining

Slavov, T., 2014. Uranium Fairytales From Kremikovci, Bulgaria, EJOLT Factsheet No. 011, 4 p.

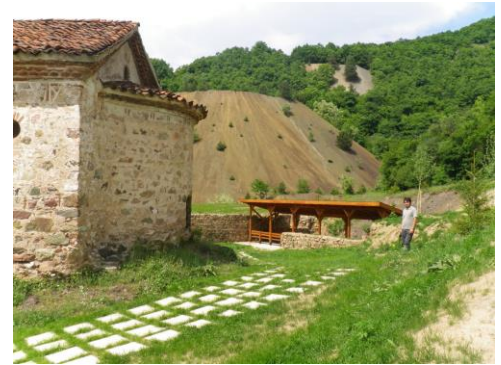
Waste rock pile located right behind a fourteenth-century monastery promoted as a tourist site.

In some cases, liquidating the uranium mine and re-cultivating the excavated ore-containing rock is difficult and requires a large amount of funds. The Seslavci waste rock pile, for instance, remains close to Seslavci monastery.

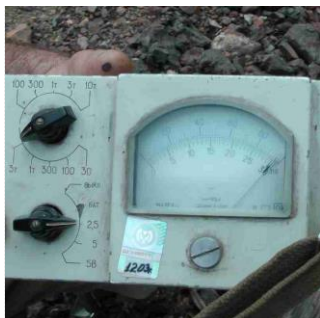
Seslavci waste rock pile. Measurement shows powerful radioactive source reaching the end of the scale of the dosimeter.

The waste piles in the region have not been re-cultivated, and the accumulated mass is being exposed to atmospheric weathering, which causes radiation to spread in the nearby areas. In addition, the on-site monitoring system no longer functions since parts of it were stolen.

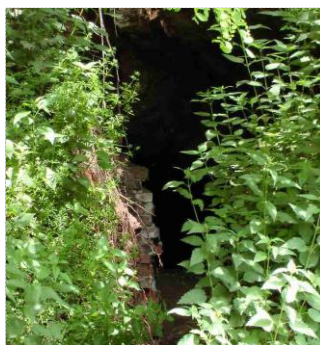
Mine adit near Kremkovci. The entrance has been opened by people looking for scrap metals. For some Romani people, this is dangerous source of income.

Almost all of the 120 adits of the mines are open, although they were once sealed. The adits are easily accessed, and waste metals left behind in the mines were stolen and sold for scrap.
